Lanterns + Foundations

Almost accident with Lanterns

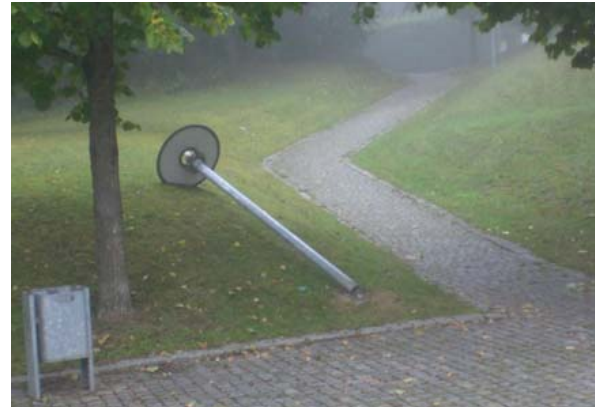
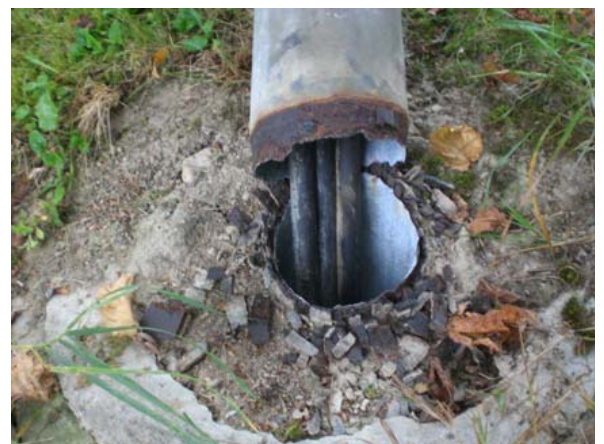
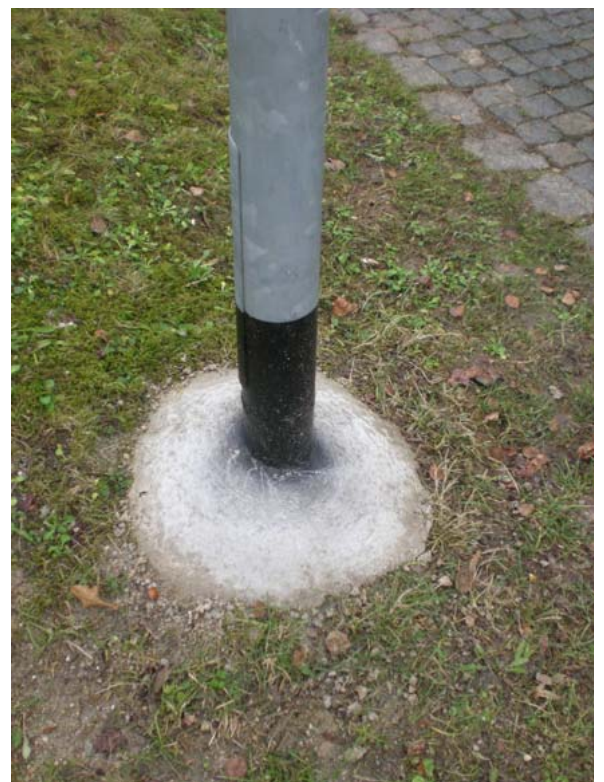
During a conversation **somebody just lightly leaned against a Lantern** that stood on the church property. **The Lantern collapsed** thereafter because it was strongly corroded at the foot-end. Thankfully no one got hit by the falling Lantern.

Afterwards every Lantern was thoroughly investigated. It has become obvious that other Lanterns were also very rusty at bottoms end and not standing securely enough. It has been suggested that the reason for this weakness is the use of salt (winter) combined with a faulty concrete-foundation. **Aggressive brine** was being collected around the Lantern-foot, not flowing off and so causing the damage.

Now during the repairing it was being made sure that the lanterns were receiving a **baffle-painting** and the **concrete-foundations** were being made in such a way that they could not collect rain any more. We recommend you look after your own Lantern and see if they show any similar signs! As you can see, even fire-zinced metal-stands can corrode gradually. The bottom-point is especially susceptible and often not in focus, since for instance plants cover up the Lantern-stand on the ground.
